Project: G241121

Project: Legacy Phase F, Liberty Lake, WA
Subject: Results of Geohazard Evaluation

At your request, we conducted geologic research and reconnaissance of the subject property and prepared this geohazard evaluation preliminary report.

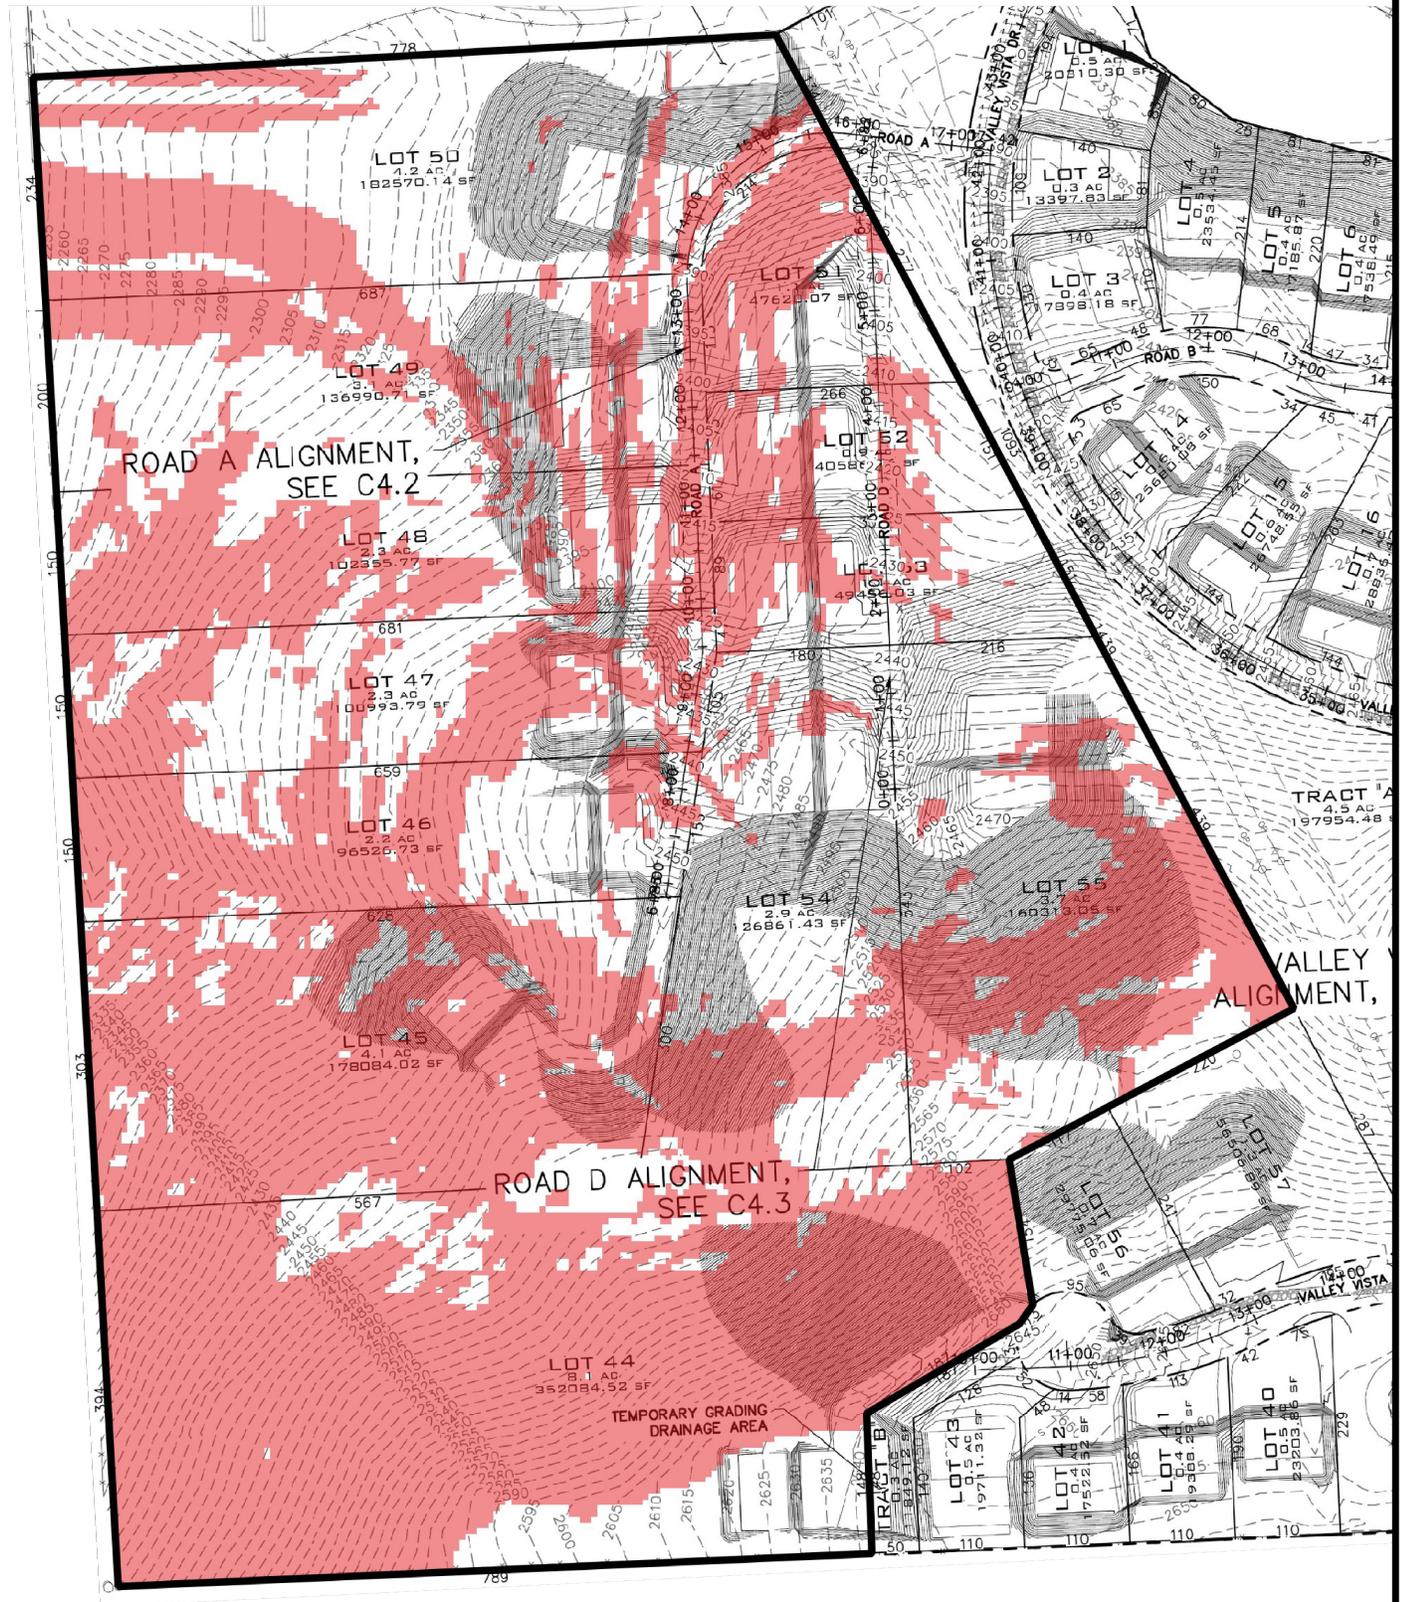
FIGURE 2-2

SLOPES 30% OR GREATER

- Slopes of 30 percent or greater are present as shown in *Figure 2-2*. Structures and pavements are not currently proposed in areas where slopes exceed approximately 40 percent with the exception of a few isolated areas of rock outcrop and shallow pre-existing road cut.
- Severe erosion potential was calculated based on soil erodibility factors defined by the NRCS and existing slope observed at the site. Results are summarized in *Table 3* below and illustrated in *Figure 2-3*.

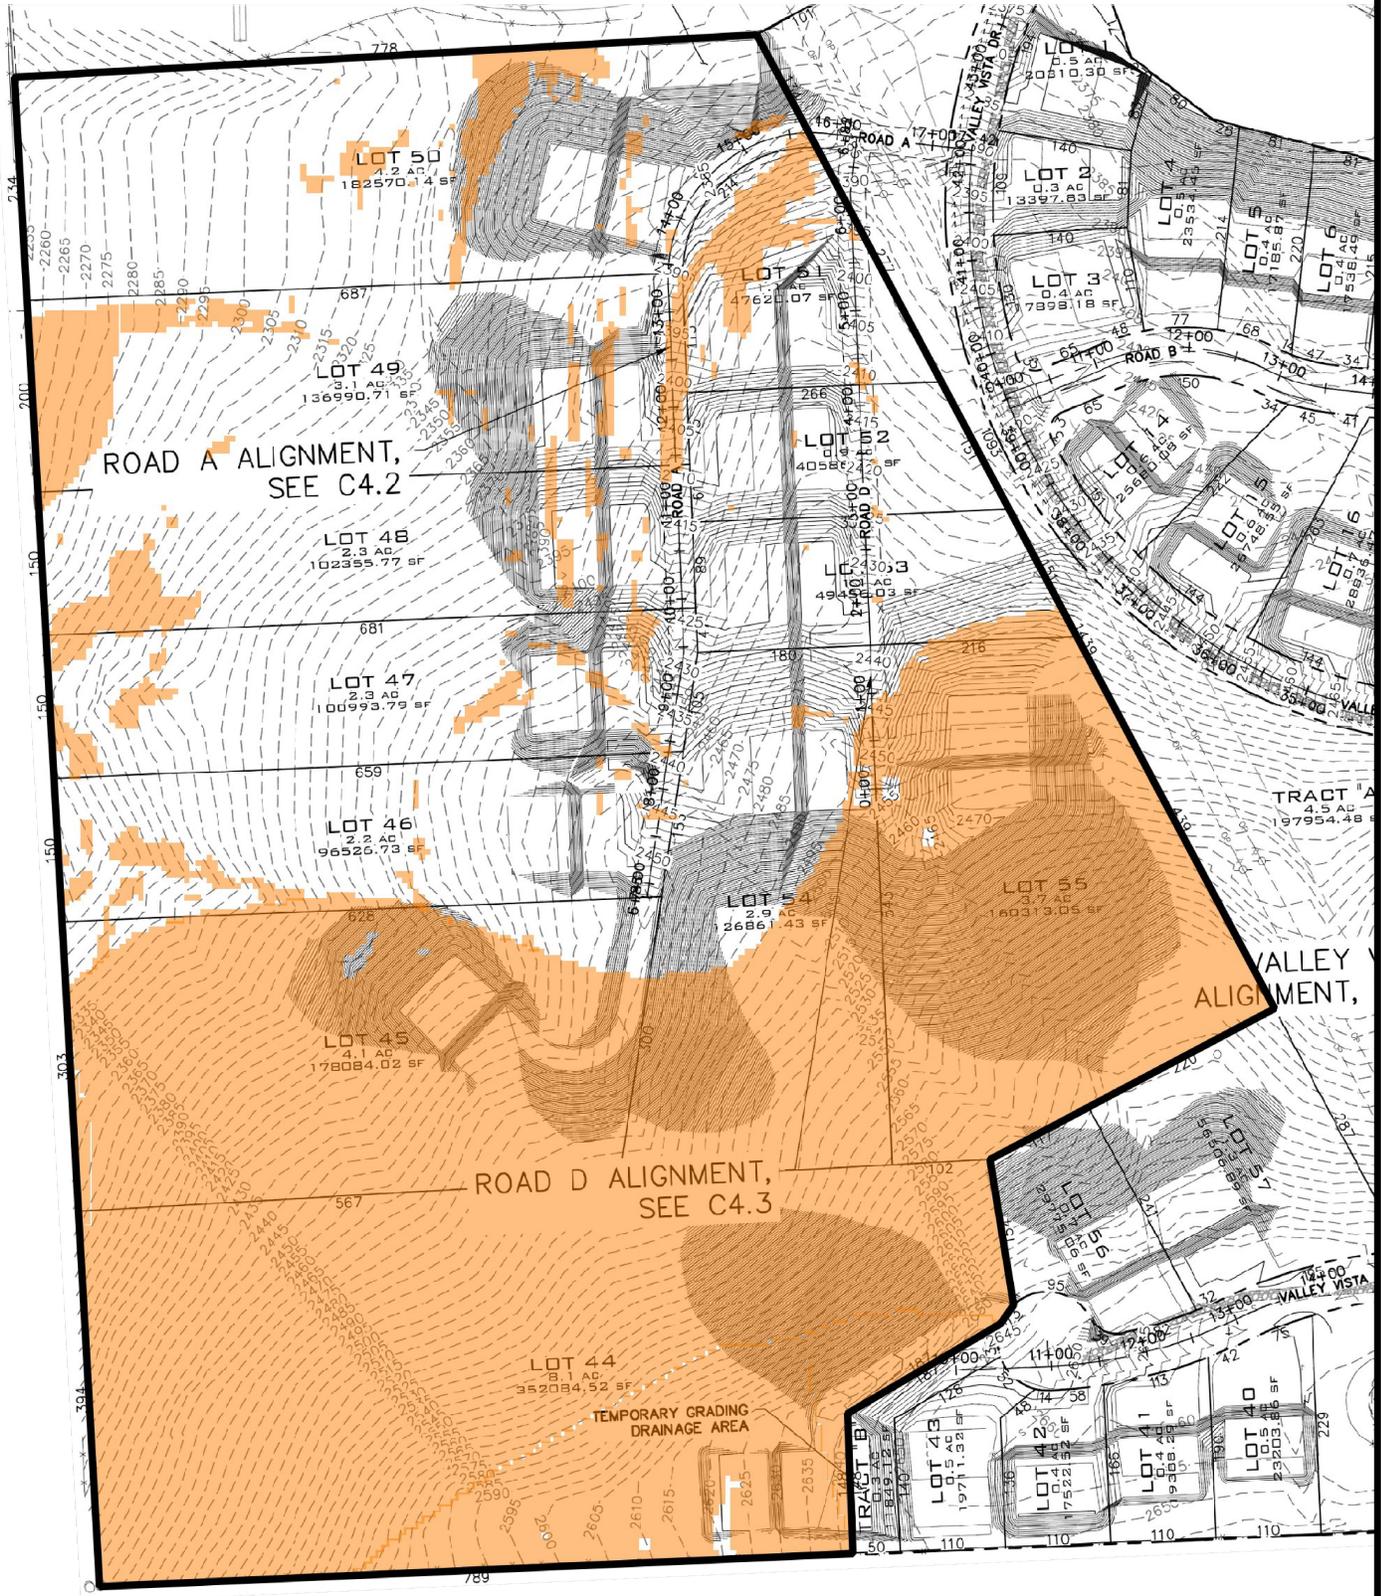
FIGURE 2-3

SEVERE EROSION POTENTIAL

Soil Unit Number	Erosion Factor Kf (rock free)	Severe Erosion Potential*
3025	0.32	Slopes greater than 12 percent
5037	0.32	
5040	0.32	
5071	0.10	Slopes greater than 40 percent
5313	0.43	Slopes greater than 9 percent

Exposed soil on slopes greater than those listed in *Table 3* above pose a severe potential for erosion and should be revegetated as soon as possible to mitigate risk of erosion. Typical construction Best Management Practices and preservation of natural drainages are anticipated to be adequate to address soil erosion issues. Dust abatement will likely be necessary during grading activities and dry periods.

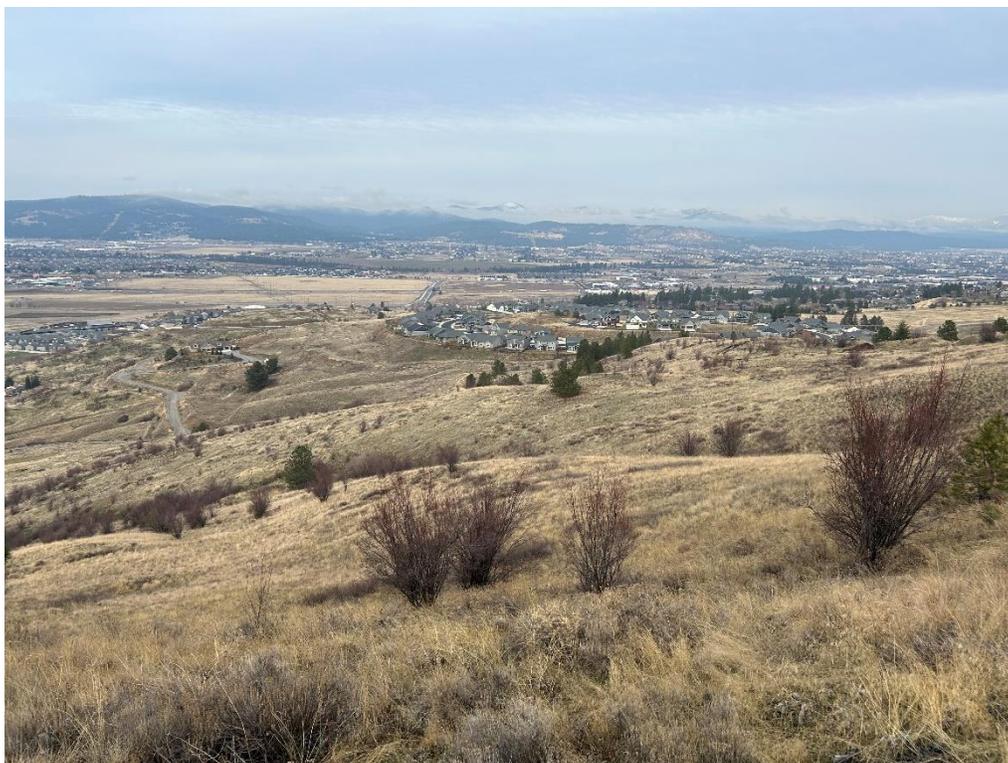
The site is on the north side of Carson Hill and spans a series of short, broad ridges that generally slope down to the northwest (see *Figure 3-1*). The ground surface was covered with low-growing grass and weeds and sparsely populated by mature conifers and shrubs. Slopes ranged from approximately 15 to 60 percent and were steepest at the southern end near the summit of the hill. Slopes in areas where building pads and roadways are proposed ranged from 15 to 40 percent.

Southwest corner of proposed development; looking north.

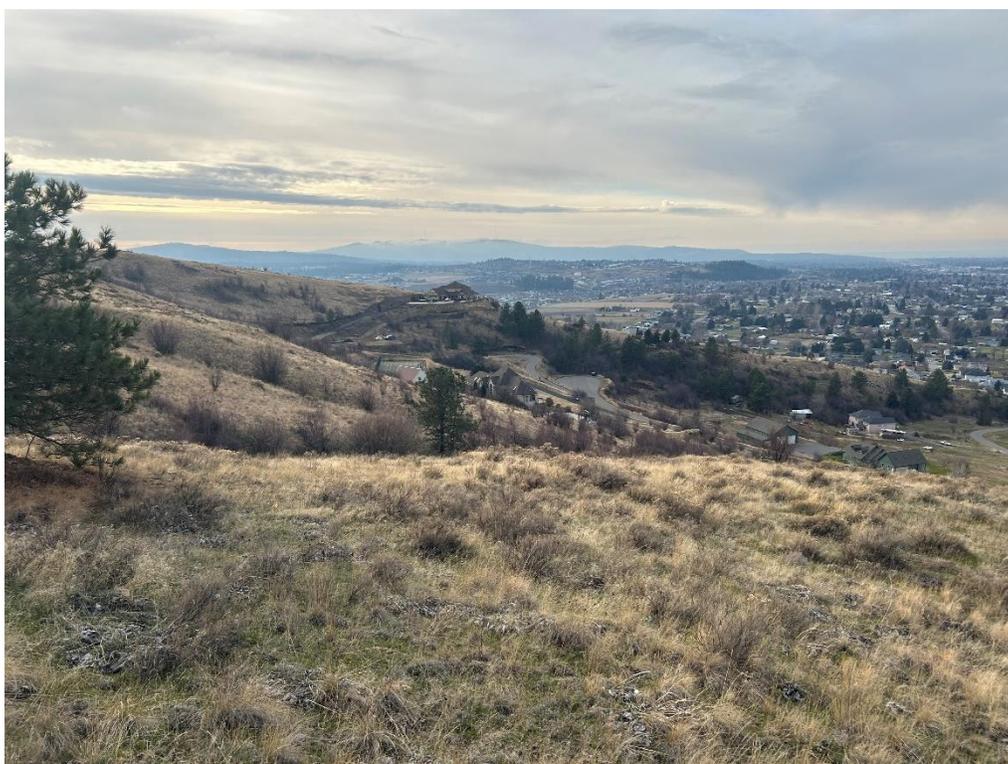
East-central side of proposed development; looking west.

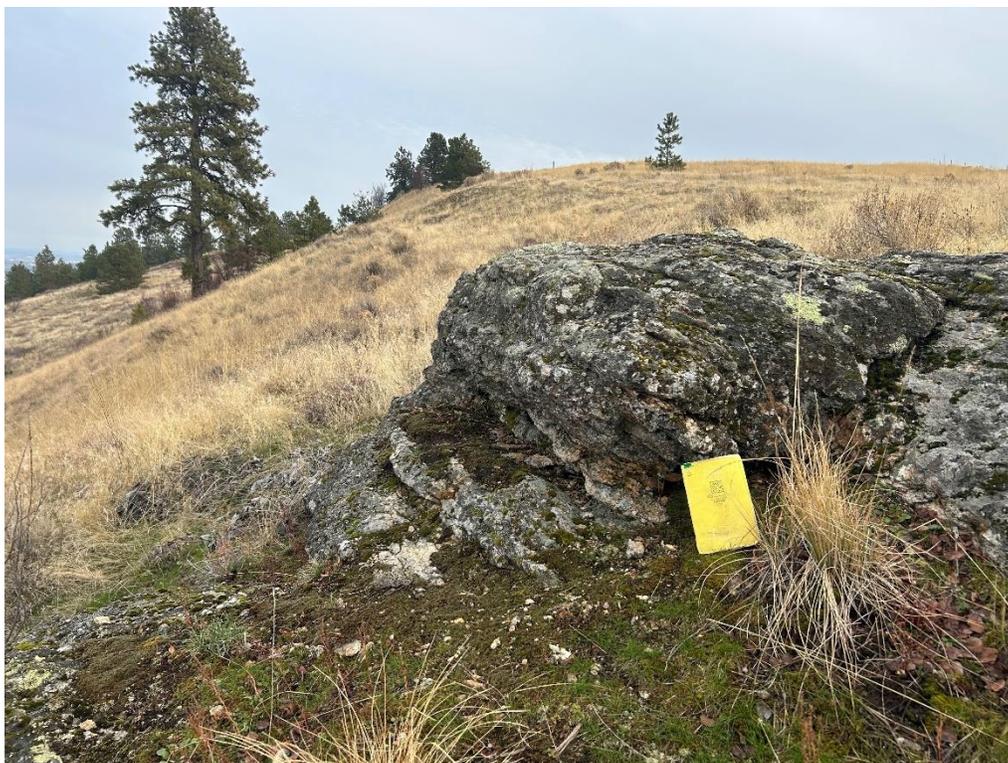
Outcrops of *gneiss* were observed in several areas throughout the site (see *Figure 3-2*). Orientations of observed foliation and joint planes are listed in *Table 2*.

Rock outcrop at southwest corner of proposed development; looking east. Notebook dimensions are 4.5 by 7 inches.

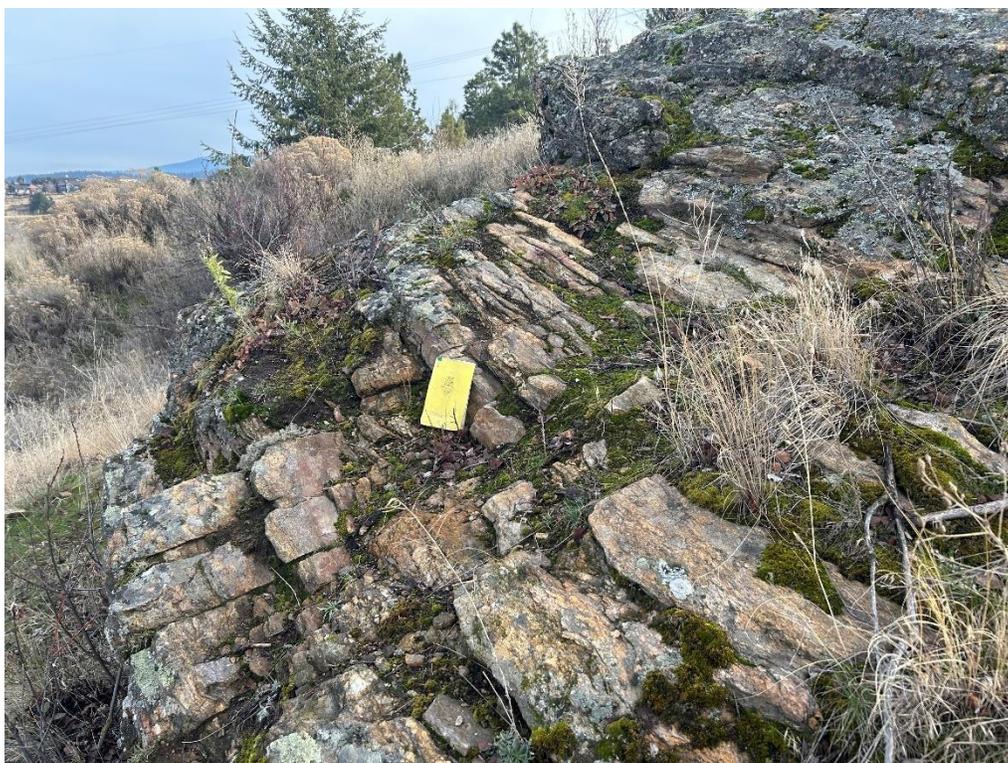
Rock outcrop at east side of proposed development; looking east.

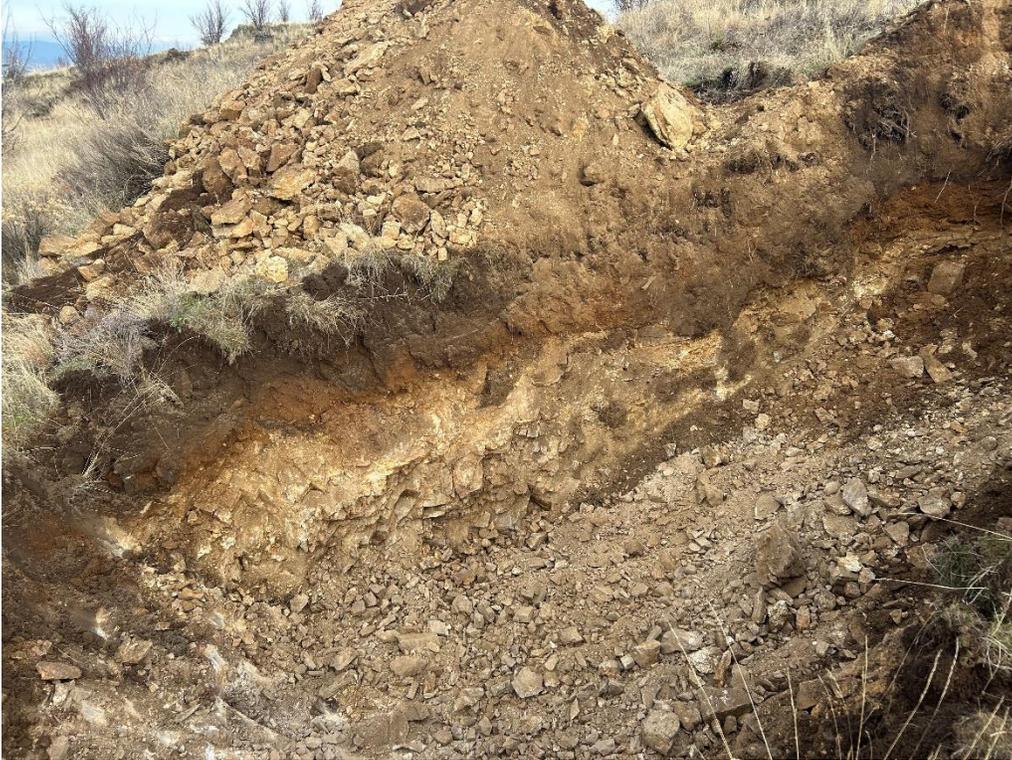
A shallow excavation at the north end of proposed “Lot 54” on the east side of the site revealed 1 to 2 feet of silty sand over *gneiss* (see *Figure 3-3*). The excavation reached a maximum depth of approximately 5 feet. Rock strength appeared to increase with depth.

Excavation at north end of proposed Lot 54. Approximately 1.5 feet of silty sand over gneiss; maximum depth of 5.5 feet.

Subsurface conditions within the site are anticipated to be very similar to those described in the previous GER, and the earthwork recommendations presented in the GER will likely be applicable to the proposed expansion of the development. We recommend completing additional exploration to verify the subsurface conditions before constructing pavements and embankment fills.

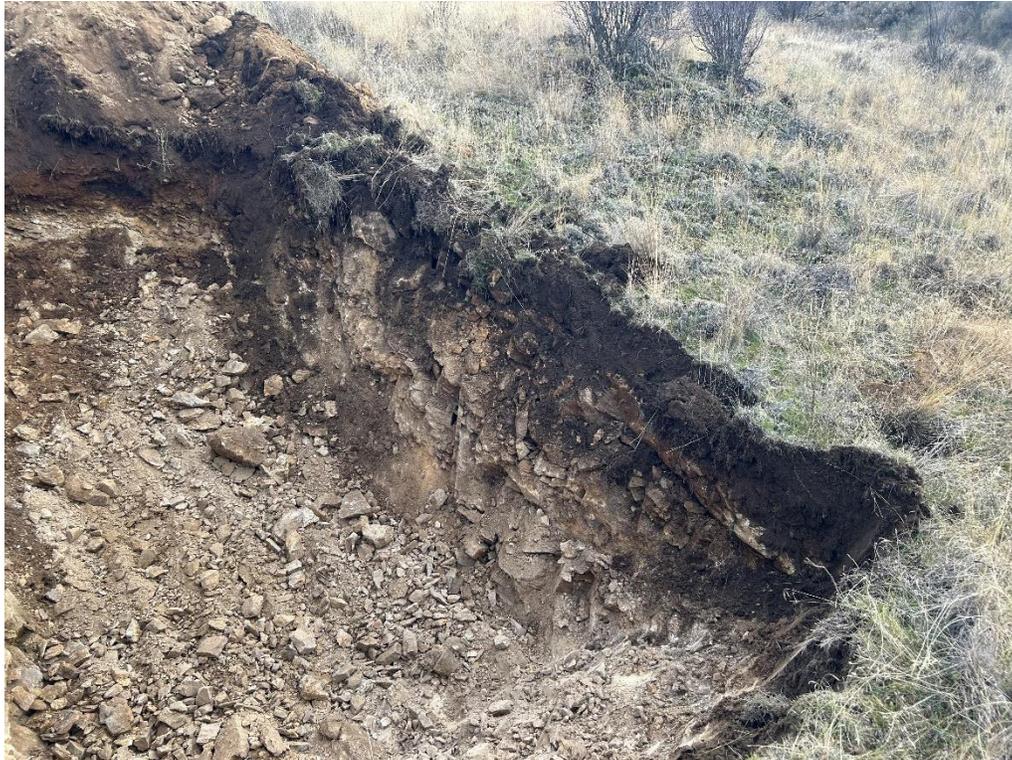
Foliation Planes:		Joint Planes:	
Dip (degrees)	Dip Direction (degrees azimuth)	Dip (degrees)	Dip Direction (degrees azimuth)
17	145	53	055
22	130	55	065
20	170	69	321
30	136	71	326
Spacing ranged from ¼ to 5 inches		Spacing ranged from ¾ to 6 inches

View inline with strike of rock joint planes.
